1963 FIAT-ABARTH 1000 GT

110-0380

SERVICE RECORD

1994-2018

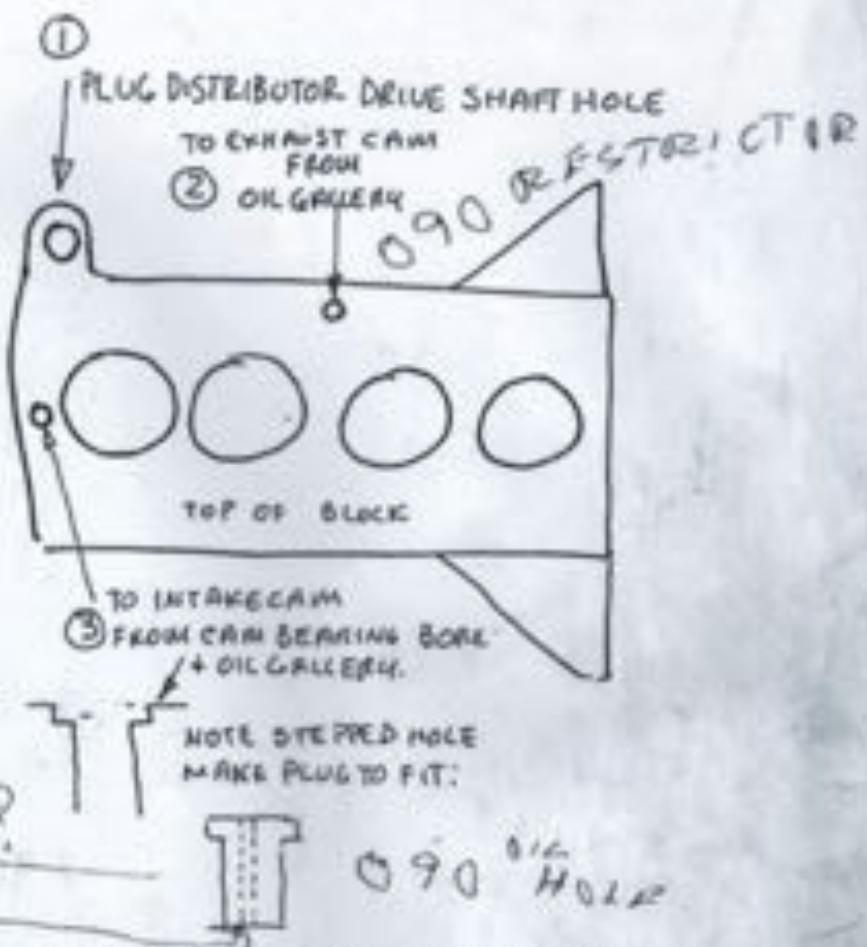
LIKE THIS?
THEY HOLE?

CHECK FIT OF HEAD GASKET TO BLOCK,
NOTE PROBLEM OF SUPPORT FOR GASKET,
HOLE IN HEAD GASKET WILL BE O-RINGED
TO PREVENT OIL LEAKS - (COMMON PROBLEMS)
DECK SURFACE MUST BE SMOOTH, PLUG SHOULD
FIT WITH NO GAP
