CONRAD STEVENSON Restorations

date 12/11/20

1961 Alfa Romeo Sprint Speciali

License Plate: Na Vin# AR*177305, Motor # AR*00120*01518

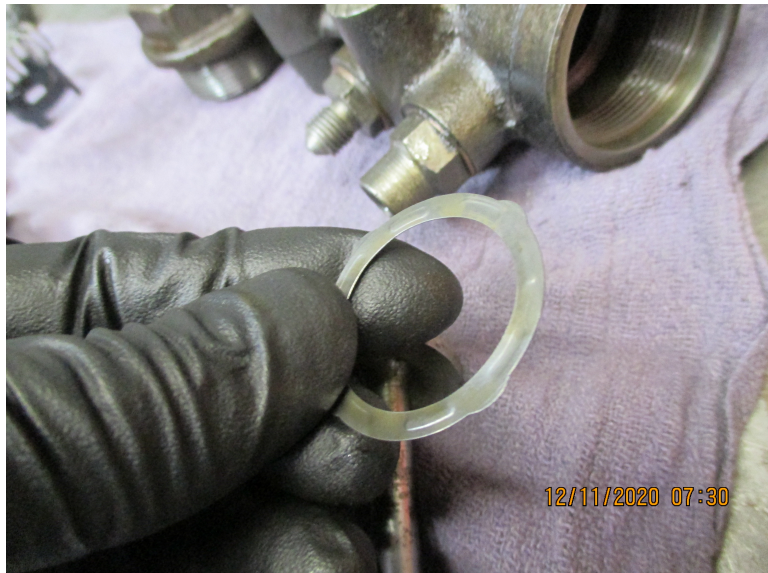
Rework master cylinder/pedal box noting that it is missing a key internal dimpled washer that allows fluid to pass through internal holes, this may have been the cause of the pedal not returning. Set cotter pin and secure master.

This is the dimpled steel washer that was missing and preventing the fluid to be able to return to the reservoir.

Light hone and polish of bore to inspect, appears to be in good condition. Fit new seal kit with new correct dimpled washer. Add pedal stop screw and adjust free play with master installed to pedal box. Refit pedal box, connecting lines and note original aluminum heat shield is missing.

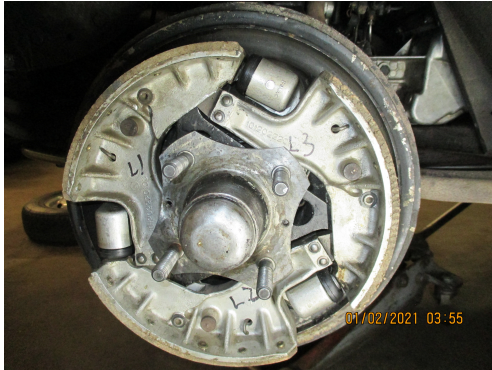
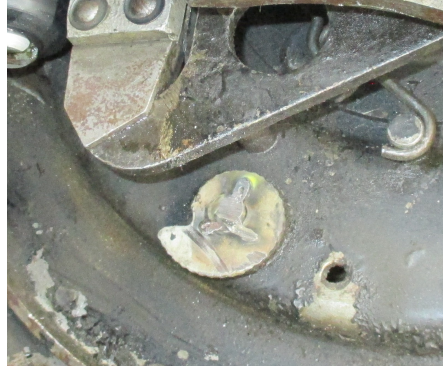
Note: very rough and over tightened front wheel bearing assembly, deep marks from roller bearings. Remove races and fit new bearings and grease seals.

New seal kits and repaired adjuster.

R&R all wheel cylinder seals. Remove brake shoes, get rear shoes relined by Porterfield. Take rear drum to machine shop to have them turned lightly to remove deep grooves. Bleed and adjust brakes.

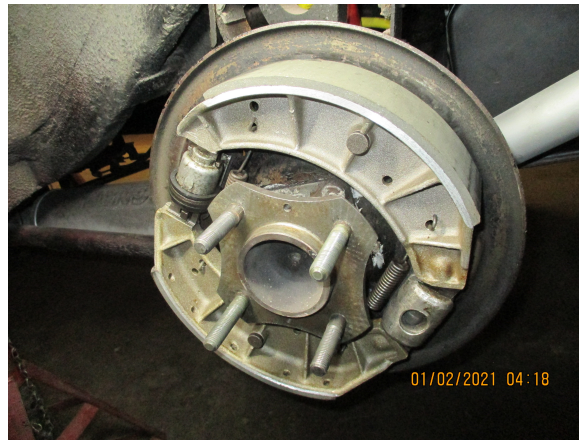
New rear brake shoe material was needed to replace material that was damp and crumbling away from aluminum shoes.
