Lotus Eleven Sports

Chassis Number 234, Engine number 107861

February 9, 2016, I was able to go over this car completely at its current location in Philadelphia, Pa.

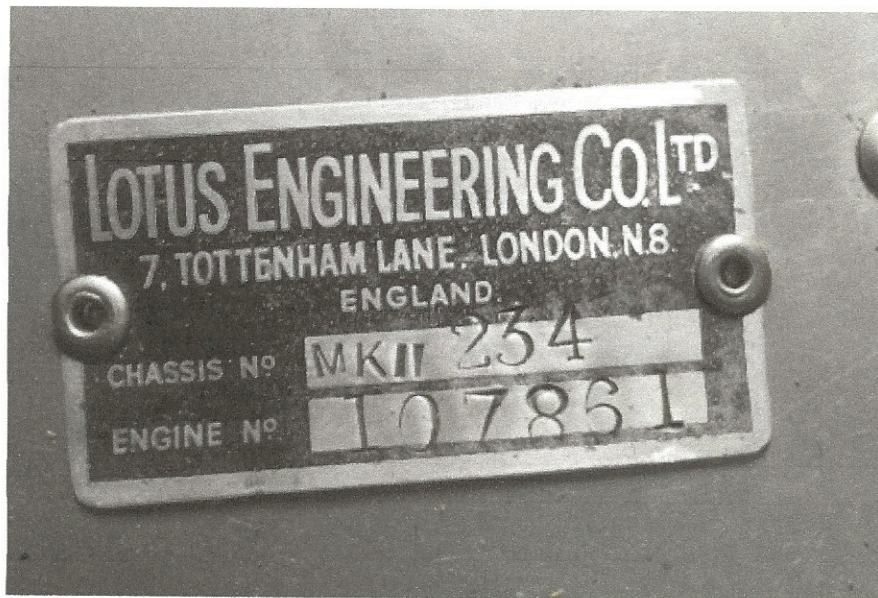
Chassis plate measures 2 $\frac{3}{4}$ " x 1 $\frac{1}{2}$ ", is embossed and has been stamped with stamps found on other similar original chassis plates. It is authentic.

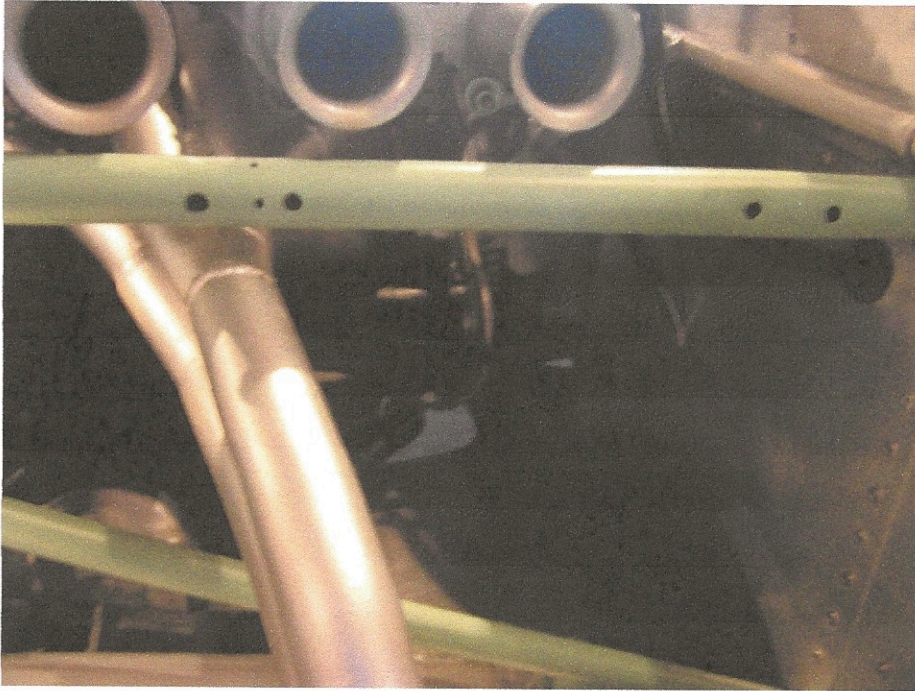
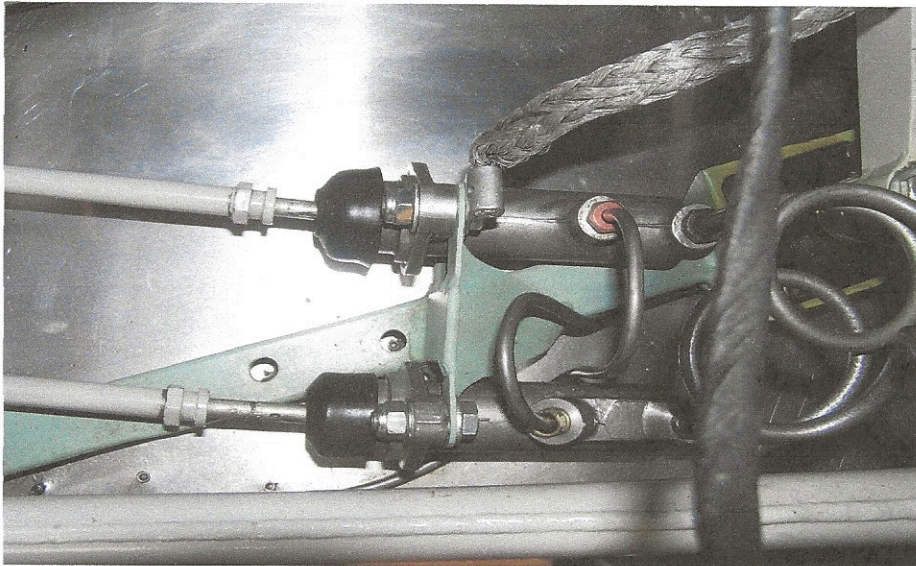
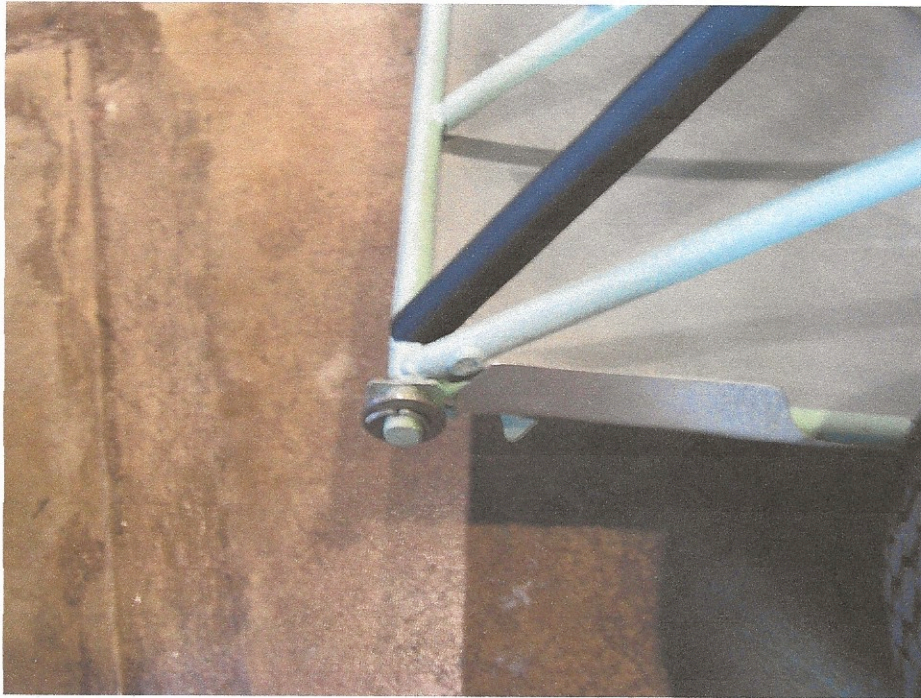
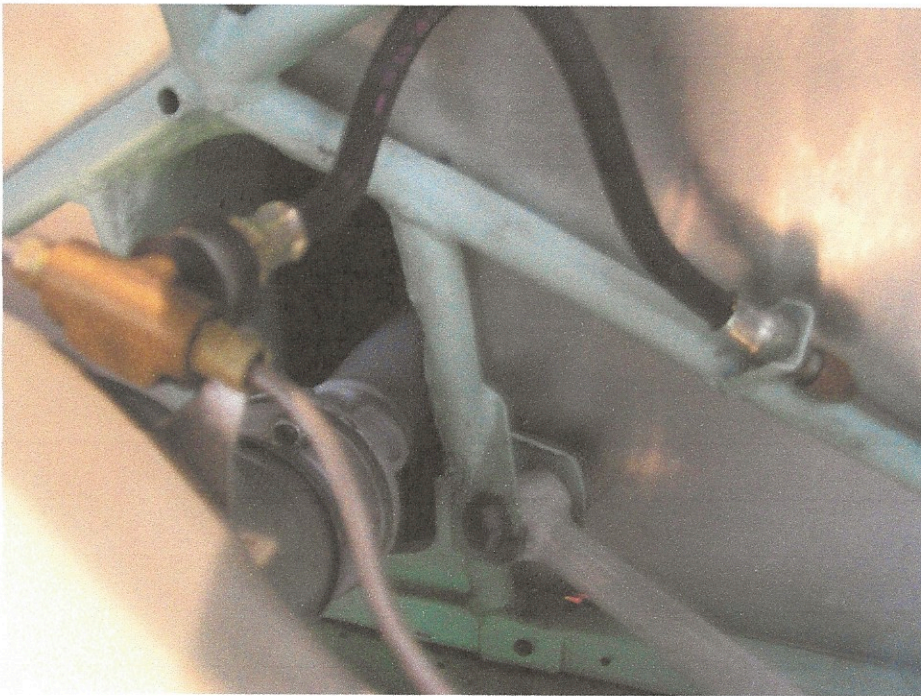
Chassis: color is a light flat green (incorrect). At first I thought the front was new from possible crash repair, but after comparing welds throughout the chassis, determined that this was an entirely new chassis. Some of the chassis brackets did appear used, but the majority appears brand new. Chassis dimensions are correct. The forward upper cross tube is perfectly straight which shows this frame has not been raced or driven hard. The channel angle was not measured. Rack & pinion mounting tubes are $\frac{1}{2}$ " square. Expansion tank mounting tube diameter is $\frac{1}{2}$ ".

There are various unusual chassis details as follows: there is no engine ground strap hole on the right lower square frame tube (use the Ford engine mounting tube holes?). The oil filter location is not correct on the lower left square frame tube. Both of these lower tubes have a pair of $\frac{5}{16}$ " diameter drilled holes, spaced $1 \frac{5}{8}$ " apart with the rear hole located 12' from the firewall (Ford engine mounting tubes?). On the upper left diagonal frame tube under the carbs there are two groupings of two, $\frac{1}{4}$ " diameter drilled holes spaced $1 \frac{5}{16}$ " apart, with the forward pair located $10 \frac{7}{8}$ " from the firewall and the rear pair located $2 \frac{3}{4}$ " from the firewall (this tube has been compressed by overtightening something thru the forward holes and has a small kink in it (the tube is still straight). I originally thought it was an original tube but after measuring it determined it to be new but damaged somehow. What was there is unknown. There is no float bracket or any carb support bracket along either upper tube. There are no SCCA seat belt mounting holes in either the seat back uprights or the transmission tunnel hoop. There are no remnants of any roll bars except the existing one. There are non-standard gussets welded upright at the seatback frame tubes and floor tubes for seat belt anchors. The rear spring upper mounts have large diameter washer welded on top rather than on the bottom of these brackets. The battery box construction is incorrect, the spare tire support tubes are straight as on very early Elevens rather than kinked. The small diameter tube directly in front of the right rear body mounting tube has been removed (this tubes helps secure the rear body from lifting).

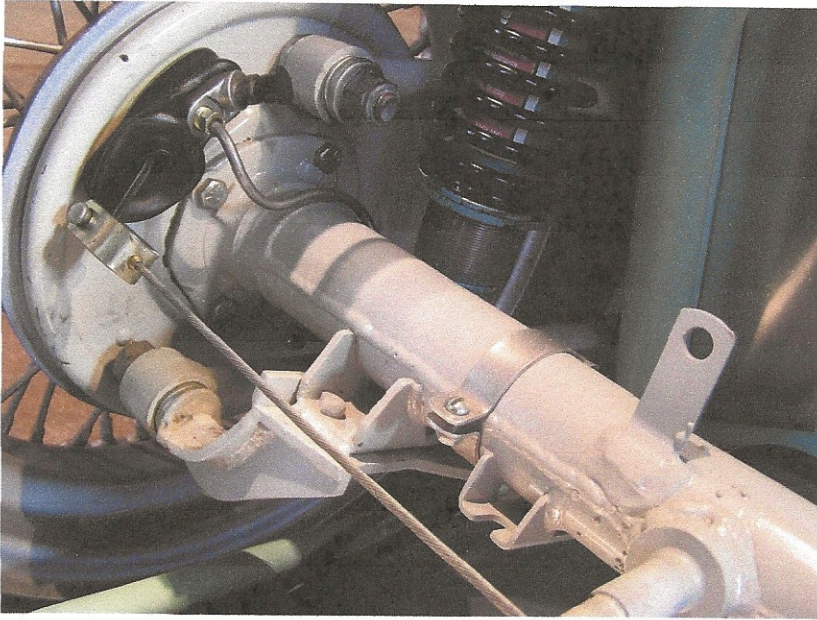
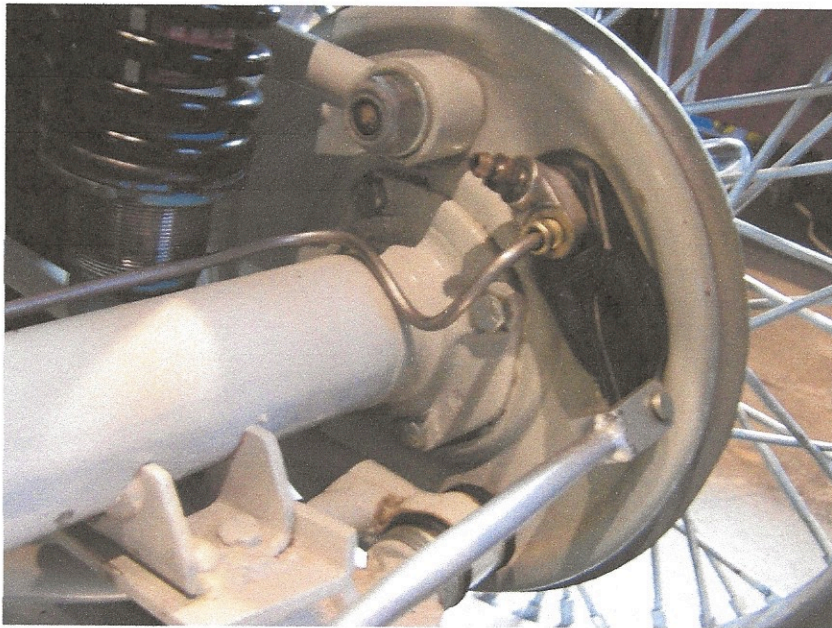
Suspension: Front appears to be completely standard with standard steering arms, except for the aggressive drilling of both the backing plates and brake drums. Rear appears to be somewhat cobbled up with the axle mounting both welded and bolted together, and the curved "A" (panhard) arm is new (this piece required many shims, approx. 5/8" worth, to fit to an Eleven). Rear drums are also drilled for cooling.

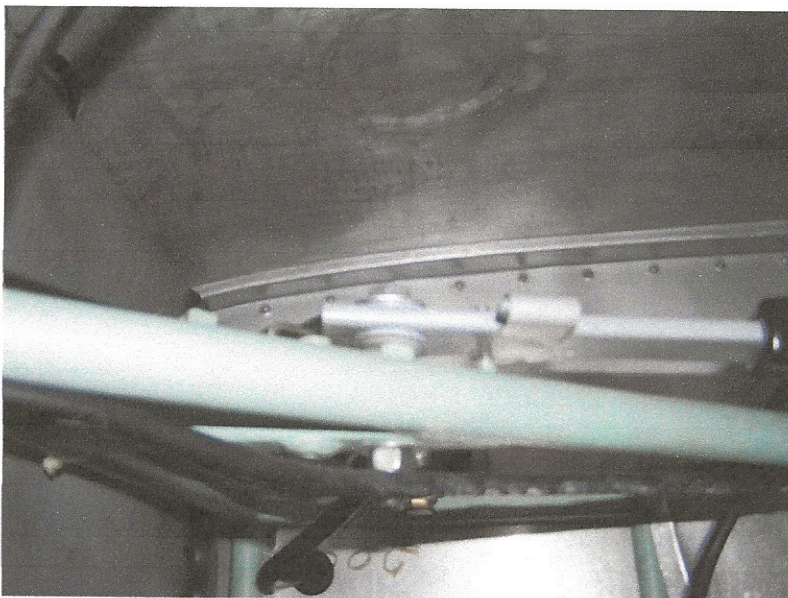
Cowl measures 21 3/4" right and 21 1/4" left. It was not removed but used an inspection mirror to visually examine the underside plus by feel. There are two, approx. 1/2" patched holes to the right of the steering wheel for mirror location(s?), or possible a street windshield mounting (holes do seem correct for any known windshield mount). This area has also been pecked out to correct some damage in this area. Because of the fuel tank and not removing the cowl, was unable to find if these same holes were located on the left side which appears new. There is no evidence of any other windscreen mounted to this panel. There are no steel street windshield mountings on the underside of the cowl. There is no recess on the left side for a tonneau cover. Above the hand brake area, there is an approx. 4" diameter patch. Below this area on the firewall there is a large patch. This panel may have been repaired on the far left side, but center/right is original. There is an approx. 3/4" diameter hole centered near the inner forward edge of the "Club" windscreen. The Club windscreen mounting frame/flange has a scallop on the left side to clear the dzus fastener. This is the same as the Road and Track Sept. '57 test car. On the firewall there are two plugged holes that could correspond with a wiper motor mounting similar to #257. If that was the case, the 3/4" hole above would allow the cable drive up to a wiper blade on a street windshield (Note, Lotus factory records indicate #234 was delivered without a windscreen). The dzus fastener is located off center inside the windscreen area.

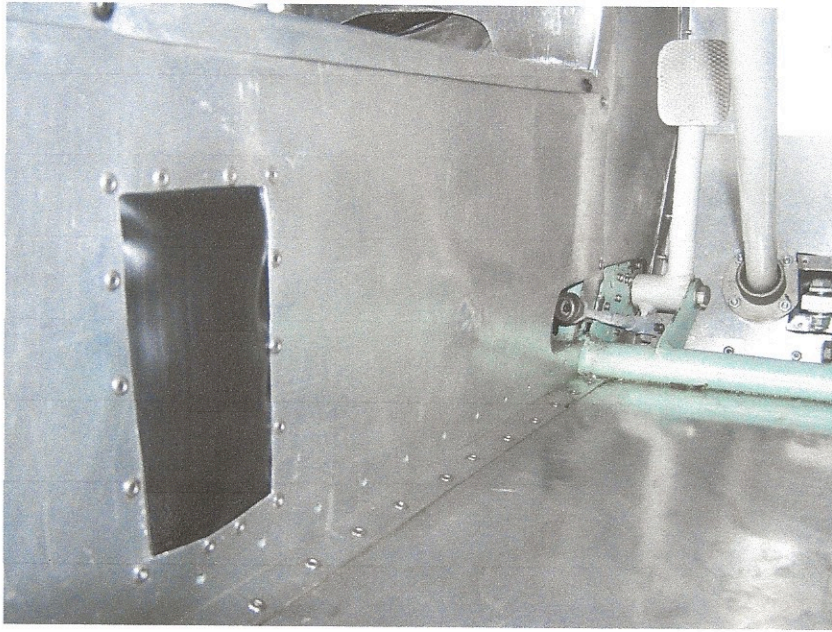
Interior: All new except possibly the bench seat back plywood. Dash is new and incorrectly assembled outside the side panels. Steering wheel is new as well as its mounting hub (both incorrect with 3 holes vs 6 hole mounting). The seat back area has been closed off with aluminum which is common, but not original, but it should be cover in the same material as the seats. Clutch pedal and brake pedal operation is correct.
