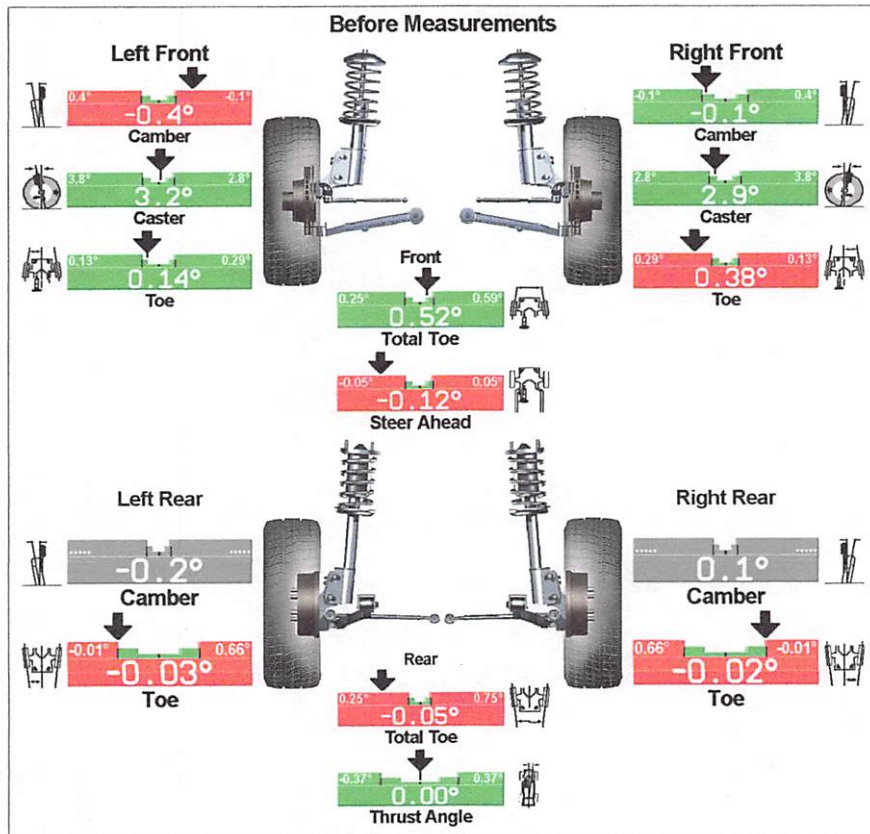
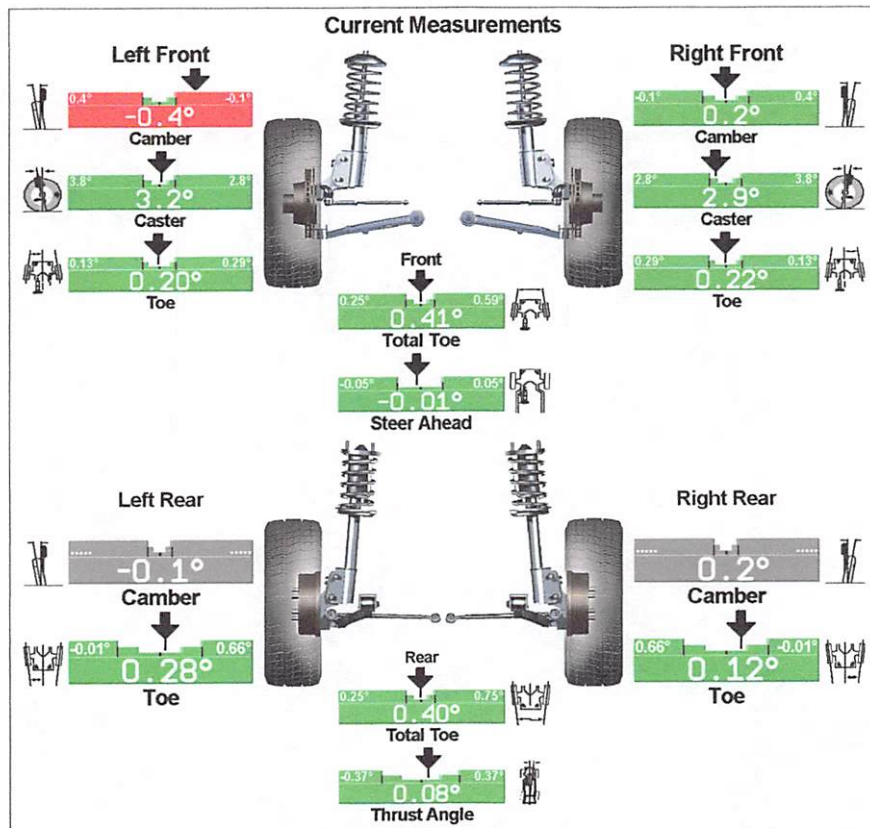
Mercedes-Benz : 114/115 (/8 1967-76) : Power Assisted Steering : Standard Suspension : without Level Control ExpressAlign Total Alignment

SLIGHT PLAY IN PITMAN ARM AND IDLER ARM
SLIGHT PLAY IN RIGHT FRONT WHEEL BEARING
CAMBER IS MAXED OUT ON LEFT FRONT

ALIGNMENT SET BEST POSSIBLE APPLABEL: VISA CREDIT[AID: A000000031010]TVR: 0080008000[IAD: 06010A03A0A002]TSI:
E800[ARQC: 238A8699246666A0]ARC: 00[CVM: S
