Lotus Eleven Sports

Chassis Number 234, Engine number 107861

February 9, 2016, I was able to go over this car completely at its current location in Philadelphia, Pa.

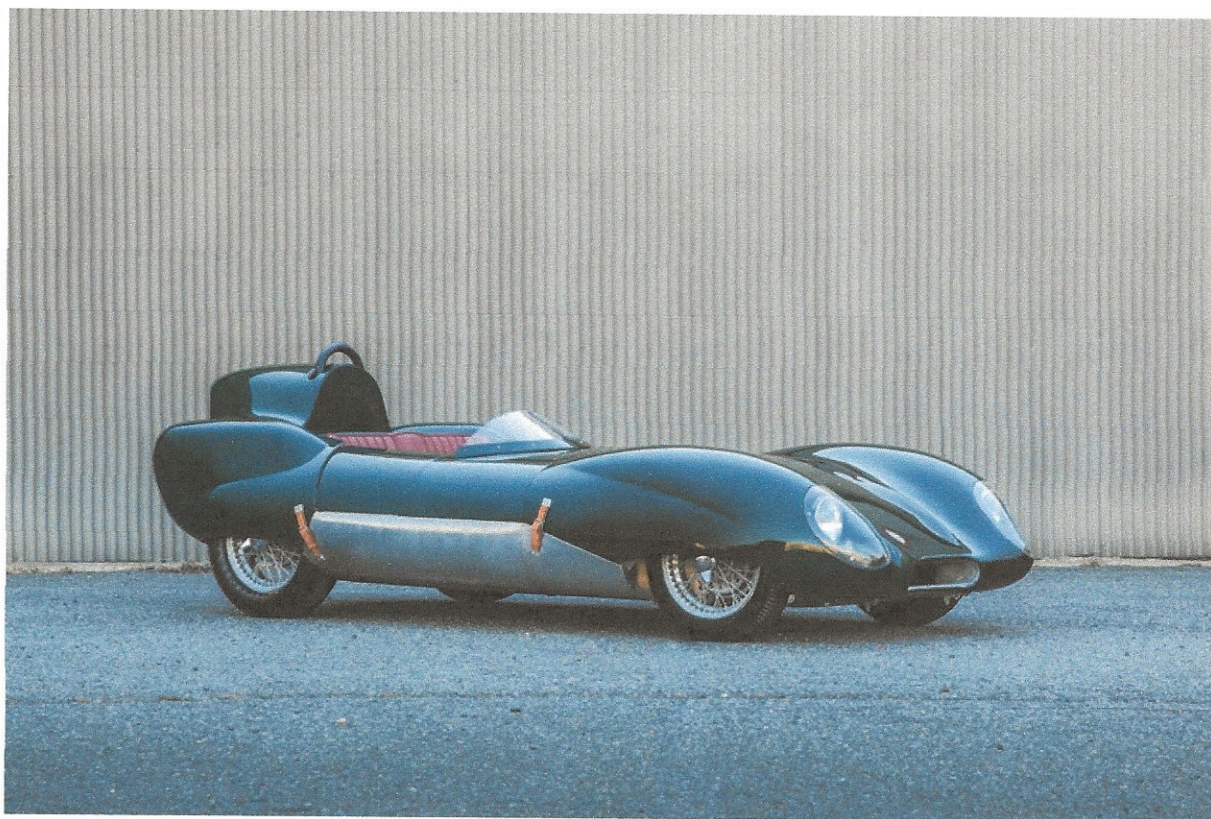
This Eleven has been updated to Club specs with the installation of a Coventry Climax FWE #7594. Date of conversion currently unknown.

It is my opinion that this is an entirely new Lotus Eleven built up around an authentic chassis tag and main body panels (bonnet, cowl, windscreen, and possibly the tail), from #234 (Note, #234 did not have a headrest when delivered). The balance of the car is new which may not be a bad thing, but its creation is currently not documented. The assembly shows many incorrect details. I have an e/m indicating the restoration was done in the early '90's, but today's condition of the car reflects a more recent completion and not a 20+ year old restoration. The unusual frame hole positions seem to show that the current frame was copied from the original frame, my only logic being why else would they be there. The pair of holes on the lower square frame tubes are likely for Ford engine mounting tubes. Chassis #257 was built the same time as #234. In examining #257 photos, similarities in details could not be determined. Some of the chassis brackets appeared old/used (clutch area) with most being new. It would have been very likely brackets off an original chassis were reused. The very important point to consider is intended future end use of this car as to how it was constructed and sits today. For racing, it would need the tub rebuilt correctly and panel fit corrected.
